Compilation of Damage Findings from Multiple Recent Teardown Analysis Programs

**25th International Conference on Aeronautical Fatigue Symposium, Rotterdam, Netherlands
May 2009**

**Gregory A. Shoales, Scott A. Fawaz
and Molly R. Walters,
USAF Academy/CAStLE, Colorado, USA**

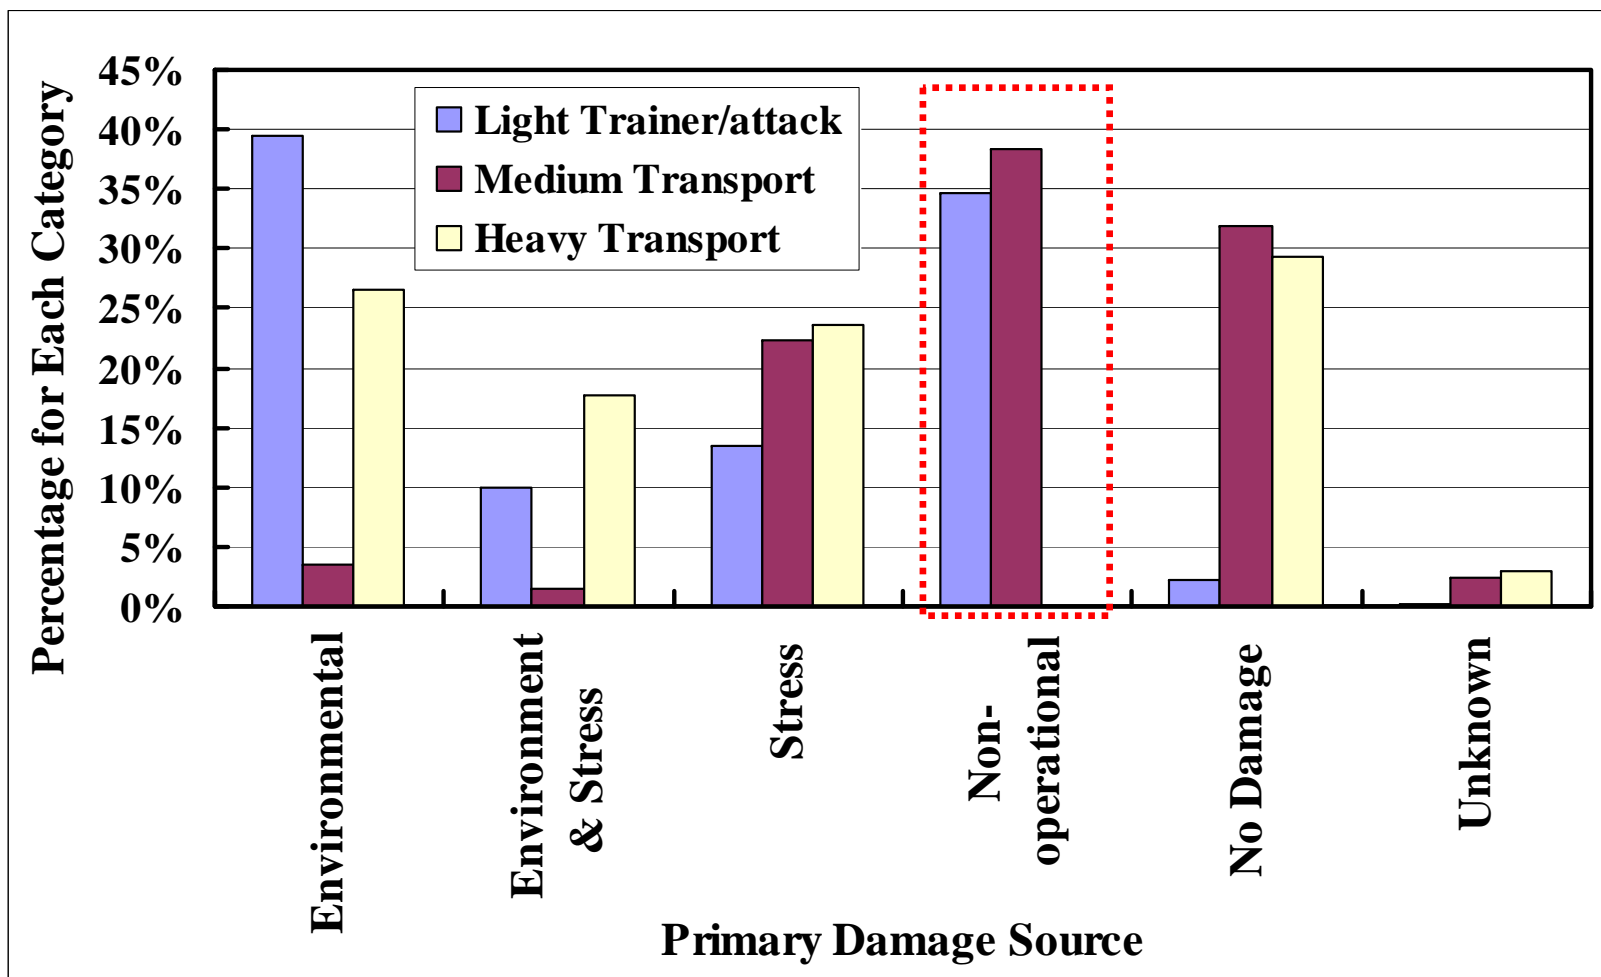
Finding Type by Aircraft Category

Production and maintenance quality indicator and programmatic decisions

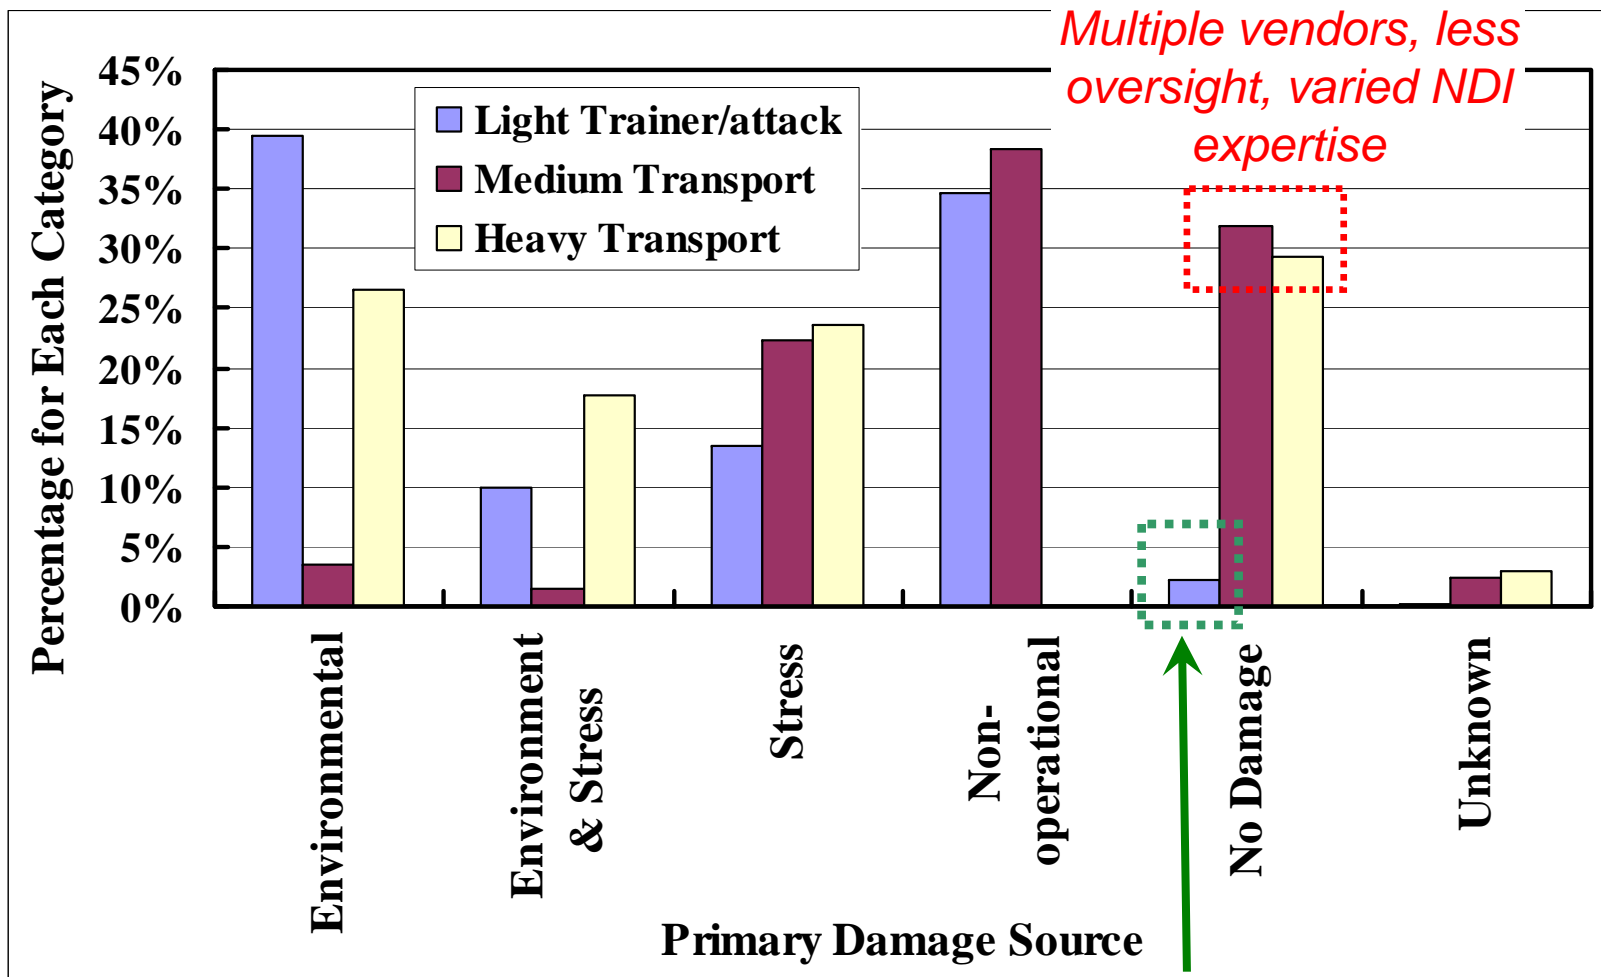
Finding Type by Aircraft Category

One highly skilled/experienced inspector, high degree of oversight

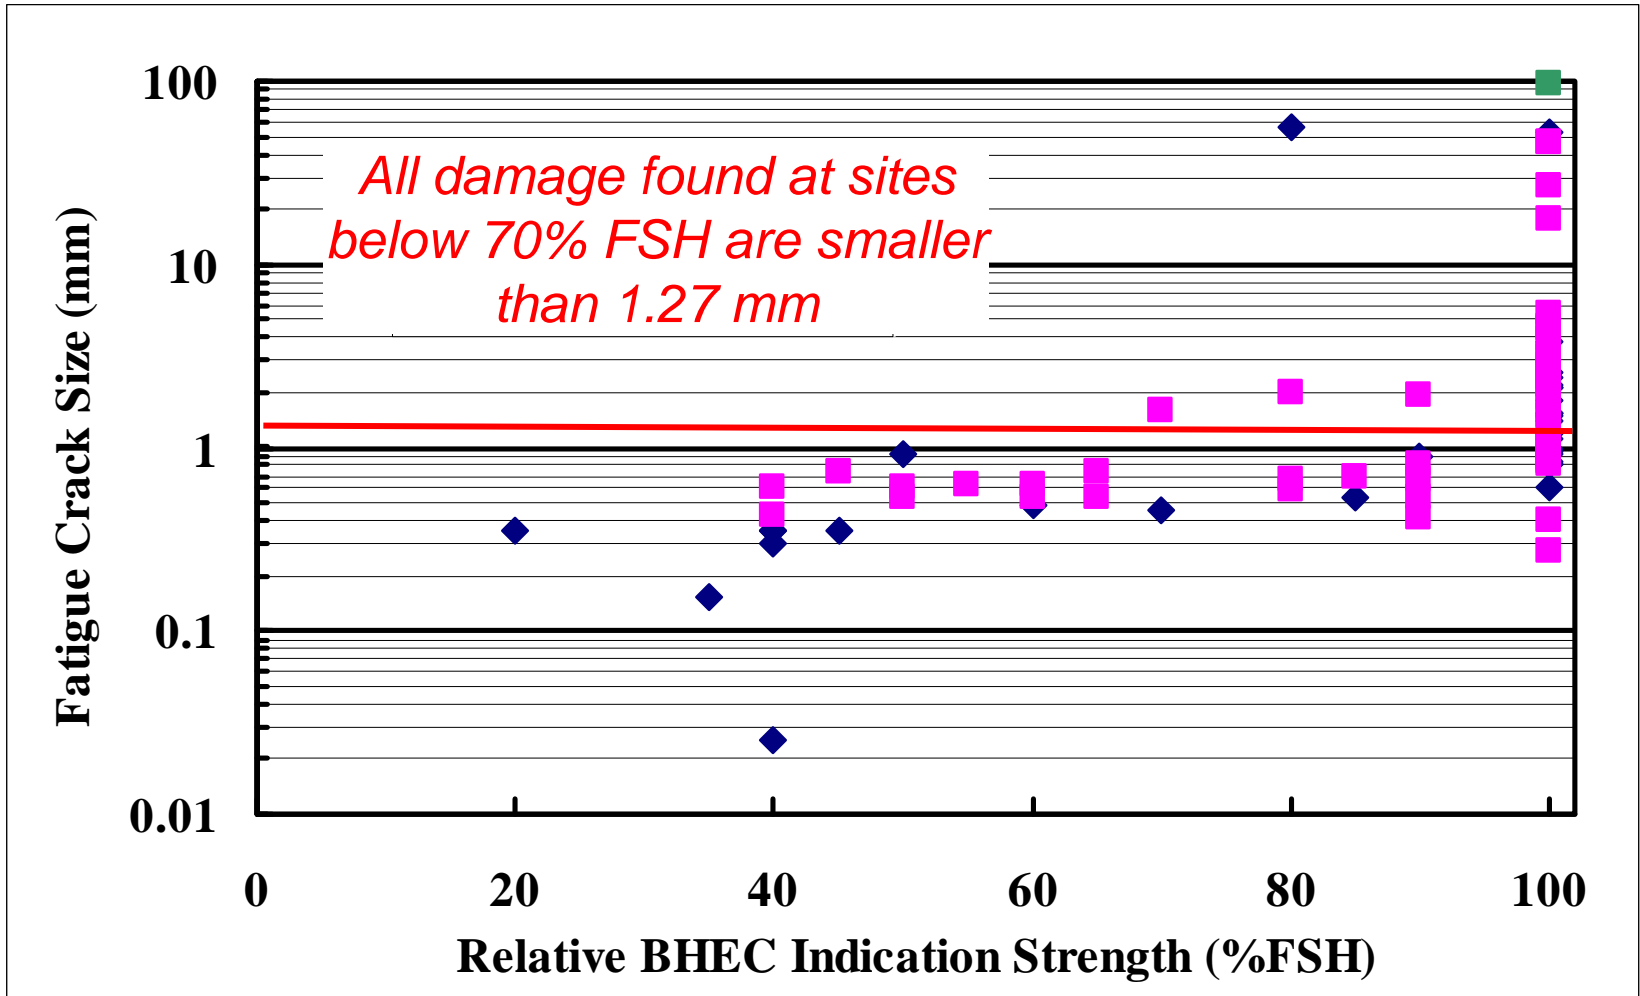
NDI Implications

fatigue crack size vs. indication strength

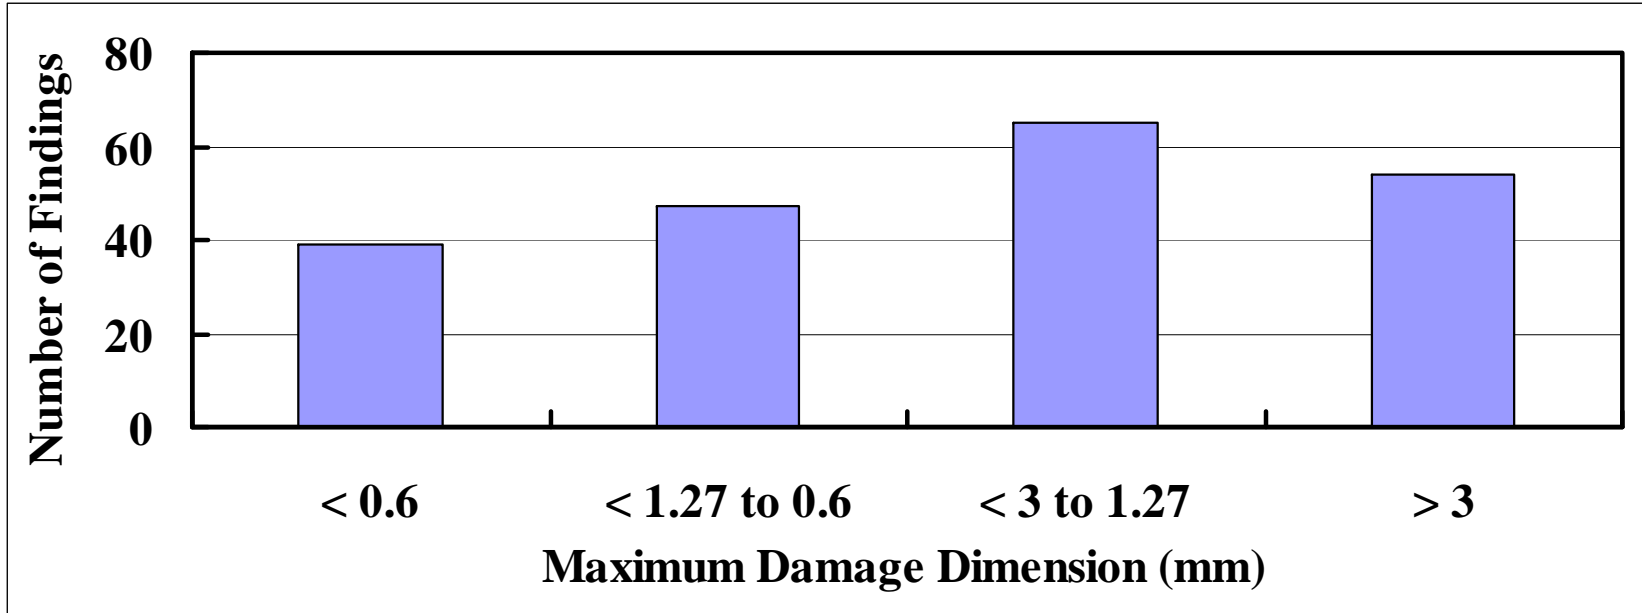
- 357 total findings
- Most corrosion and most fatigue cracks are in hidden, 2nd layer, unreliable operational NDI available, if any
- SCC cracks in skin; 4 in each of the transport aircraft
- In-plane cracks; no available inspection

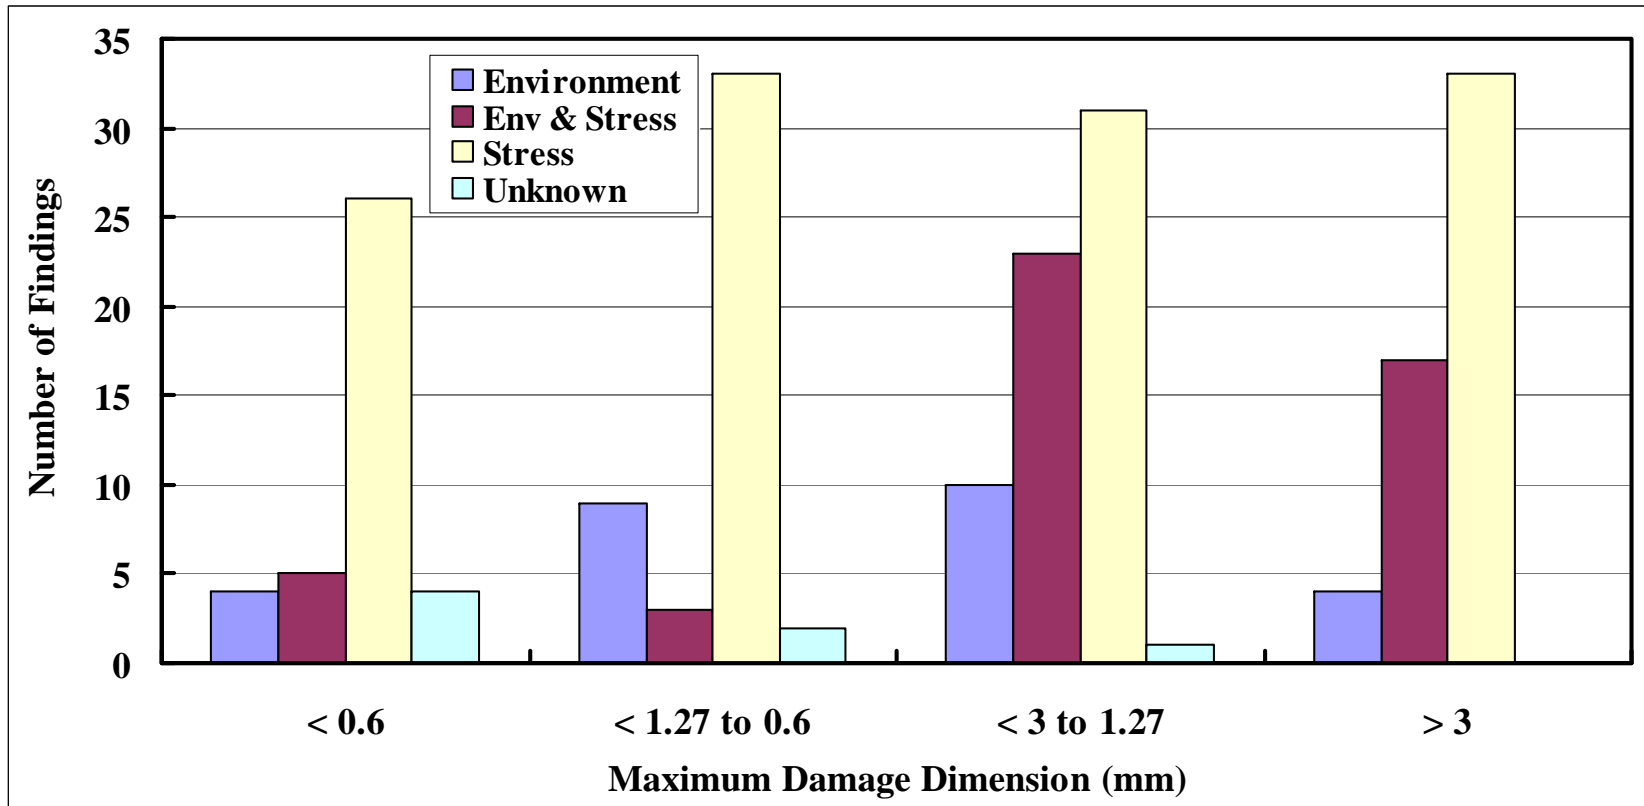
- 205 crack findings attributed to operational usage
- 42% are smaller than 1.27 mm
- 4 findings are smaller than 0.127 mm

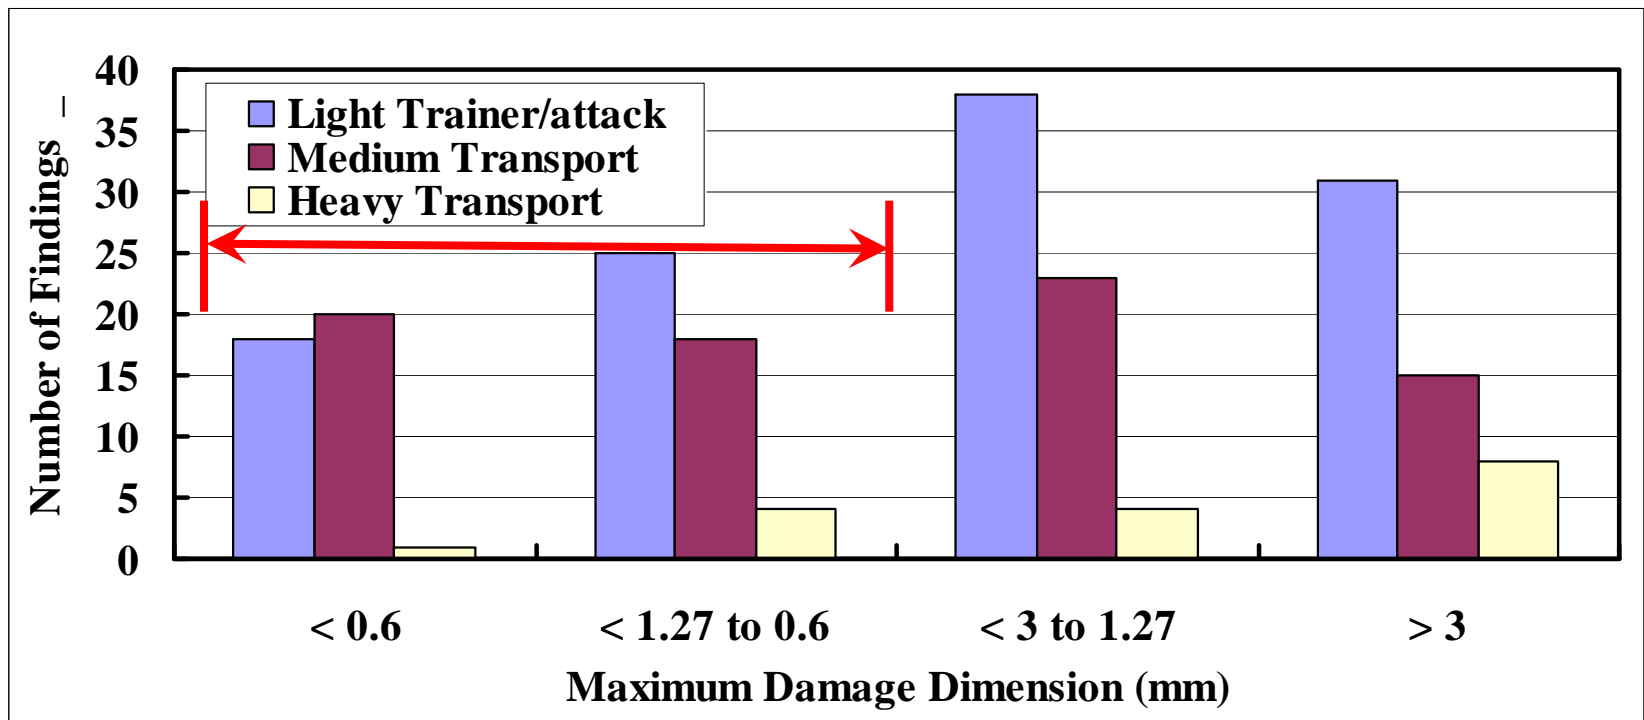
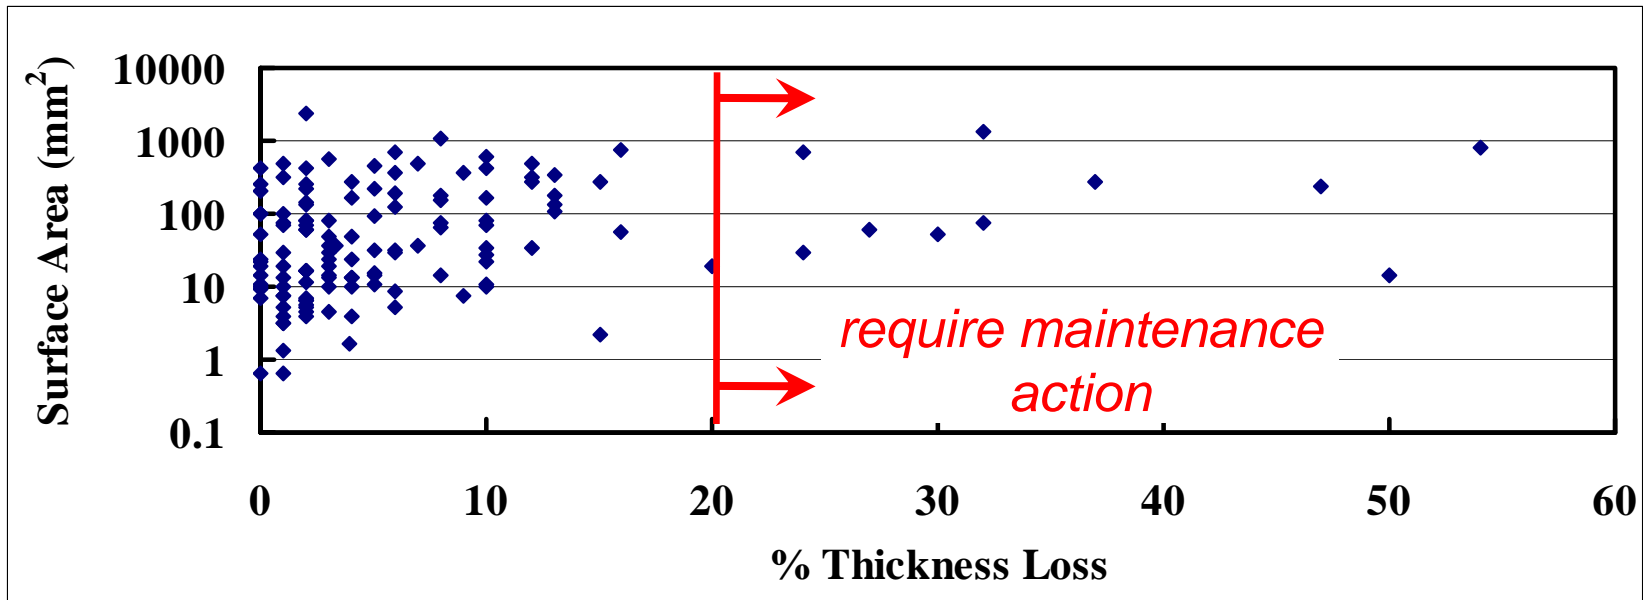
- Majority of damage is due to stress
- “Unknown” only exists in the very small scale damage

- Lower two bins represent part through cracks for all three aircraft categories
- Lower three bins are part through cracks for medium transport

- Light Trainer/attack category only
 - No corrosion damage evaluated in medium transport
 - Severe corrosion in one region attributed to retirement decision
 - No additional corrosion found during teardown program
 - Corrosion damage ignored in heavy transport
- Most damage broad but not deep
- Only 10 of 138 require maintenance action

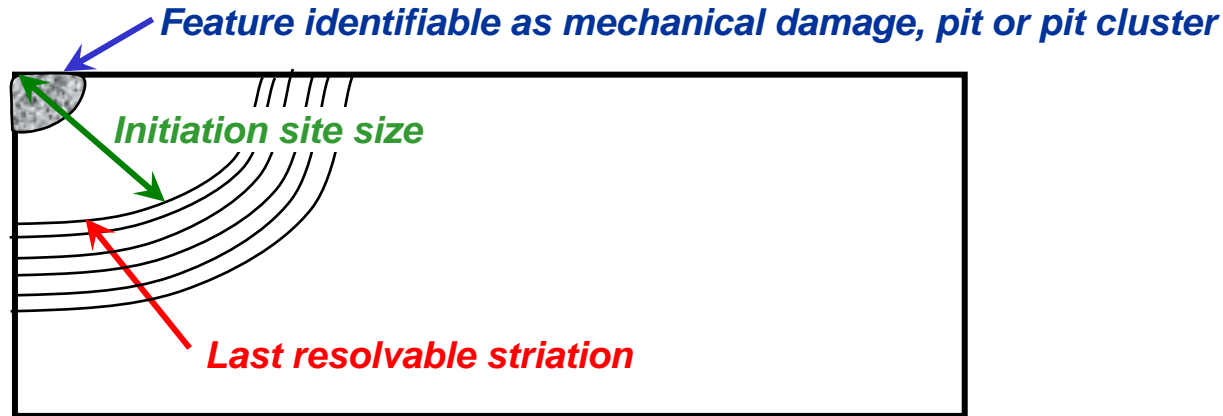
- What is “initiation feature size”?

- Even with conservative approach, the largest site is 0.624 mm
 - 90% are less than 0.254 mm
 - 48% are less than 0.127 mm

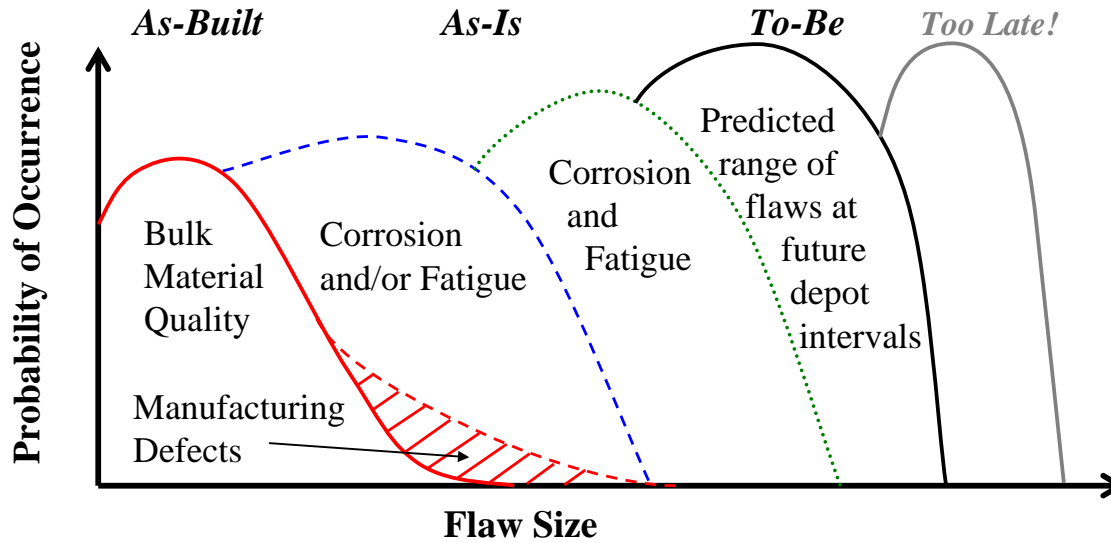
literature compared to the present work

Similar distribution of corrosion pits as identified for the defects (mechanical damage)
