EVALUATION, MODIFICATION AND DAMAGE TOLERANCE OF AN IN-SERVICE AIRCRAFT CRITICAL AREA

25th ICAF Symposium – Rotterdam, 27–29 May 2009

R. S. Rutledge, D. S. Backman and R. J. Hiscocks

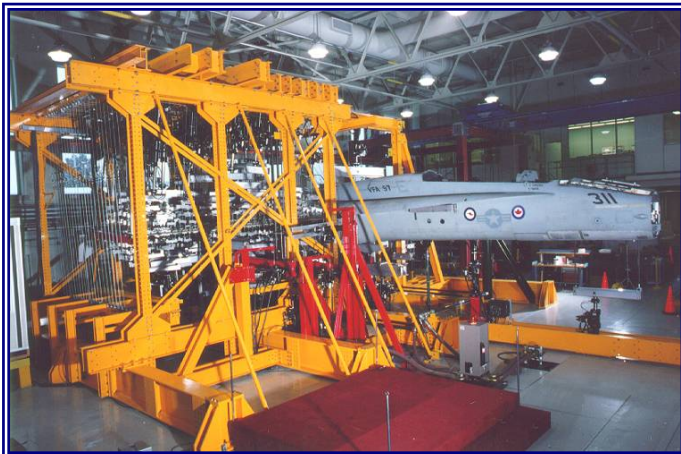
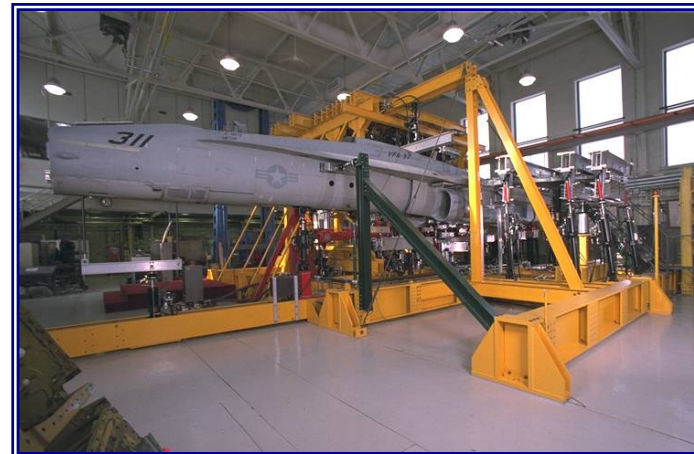
The IFOSTP Tests

- In Australia:
FT46 – real-time quasi-dynamic test of the rear fuselage and empennage.
- In Canada:
FT55 – at L3 Com / BA, Mirabel. Fatigue test of centre fuselage.
FT245 – at IAR, Ottawa. Fatigue test of inner and outer wing boxes.

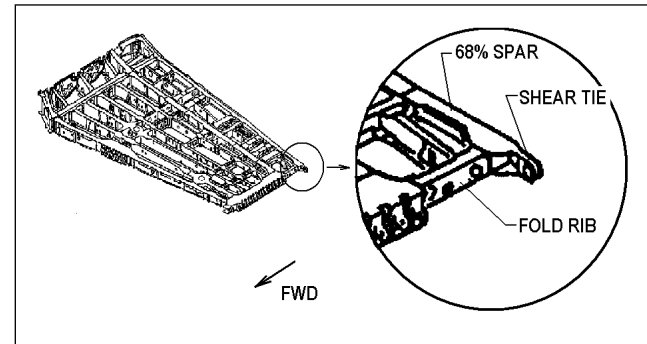
In service damage ...

- Cracks were found in the wing-fold aft-spar shear-ties of in-service aircraft.
- FT245 fatigue test spectrum was not severe enough?
or Surface preparation for strain gauges may have removed acid etched surface damage - typically present on all aluminium on this aircraft.
- Acid etch damage - a by product of the cleaning process applied just prior to corrosion prevention ion vapour deposition at manufacture.

- To repair the cracks in the fleet wing shear-ties, various blends were proposed.
- Due to the severity of the problem, NRC Canada - tasked for a local fatigue test on the aft-spar shear-tie on an inner wing.

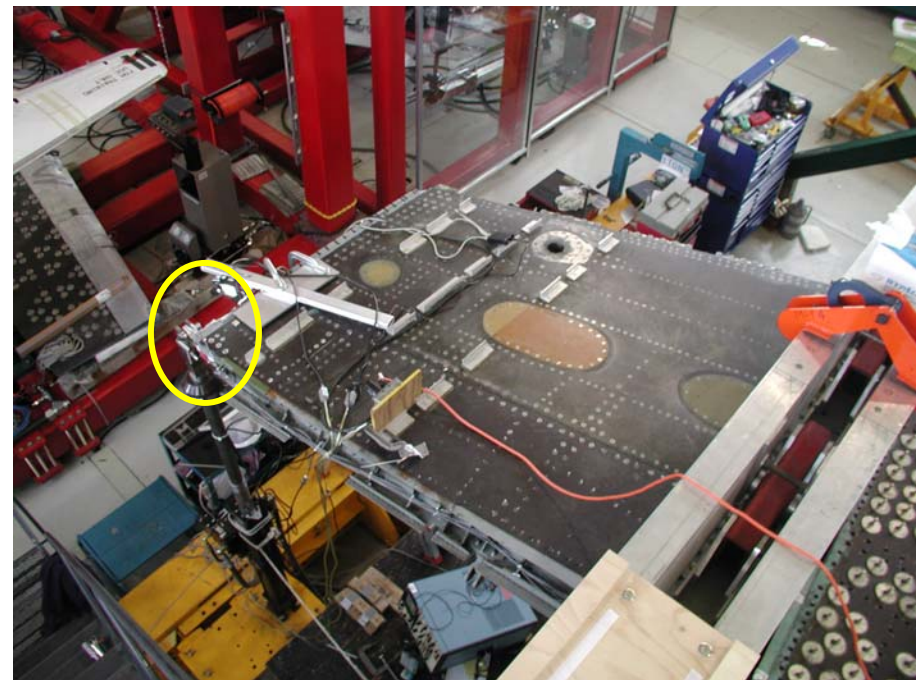
Specimen

- Port Wing of FT245 was used as the test specimen.
- Serial A12-0312 was retired, 60% of one RLLs of usage.
- Wing fold shear-tie area not loaded during FT245 testing.

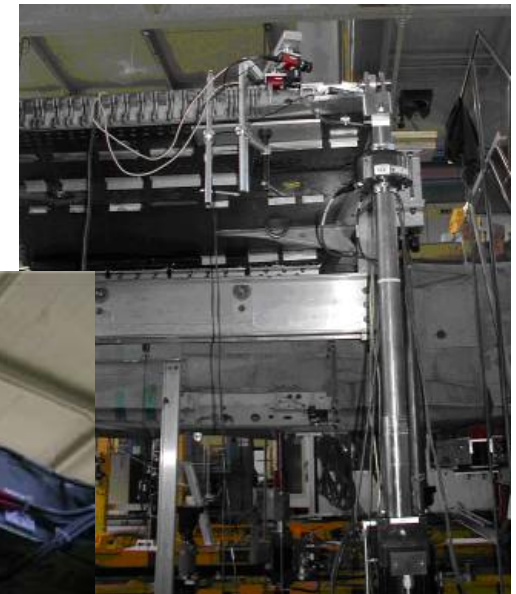
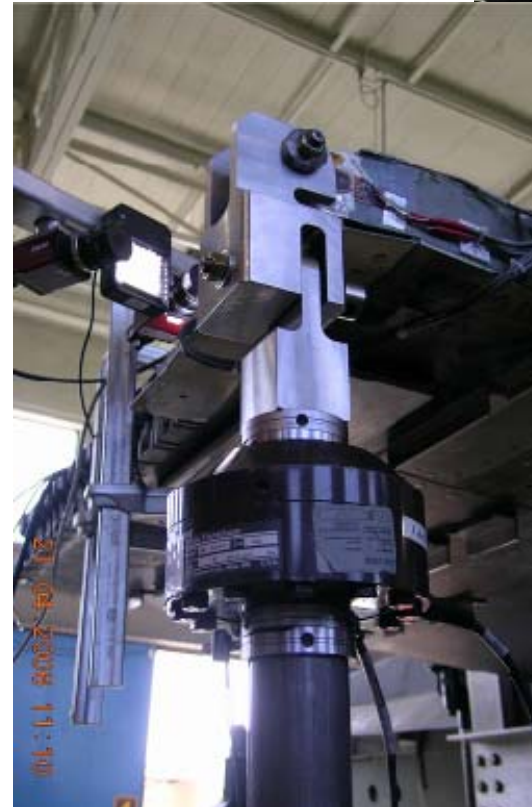
Test Rig Configuration

- Double lug arrangement.
- Single actuator / load cell.
- Three different offsets considered in the spectrum development.

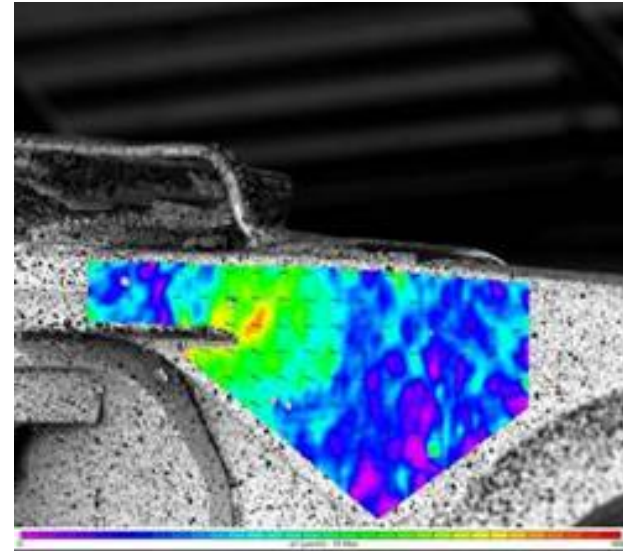
47% DLL Down

- Pre-test strain survey used to obtain desired strain distribution.
- Strains measured using digital image correlation and eight strain gauges.
- A 7.62 mm (0.3 inch) lug aft offset was selected for the fatigue test.

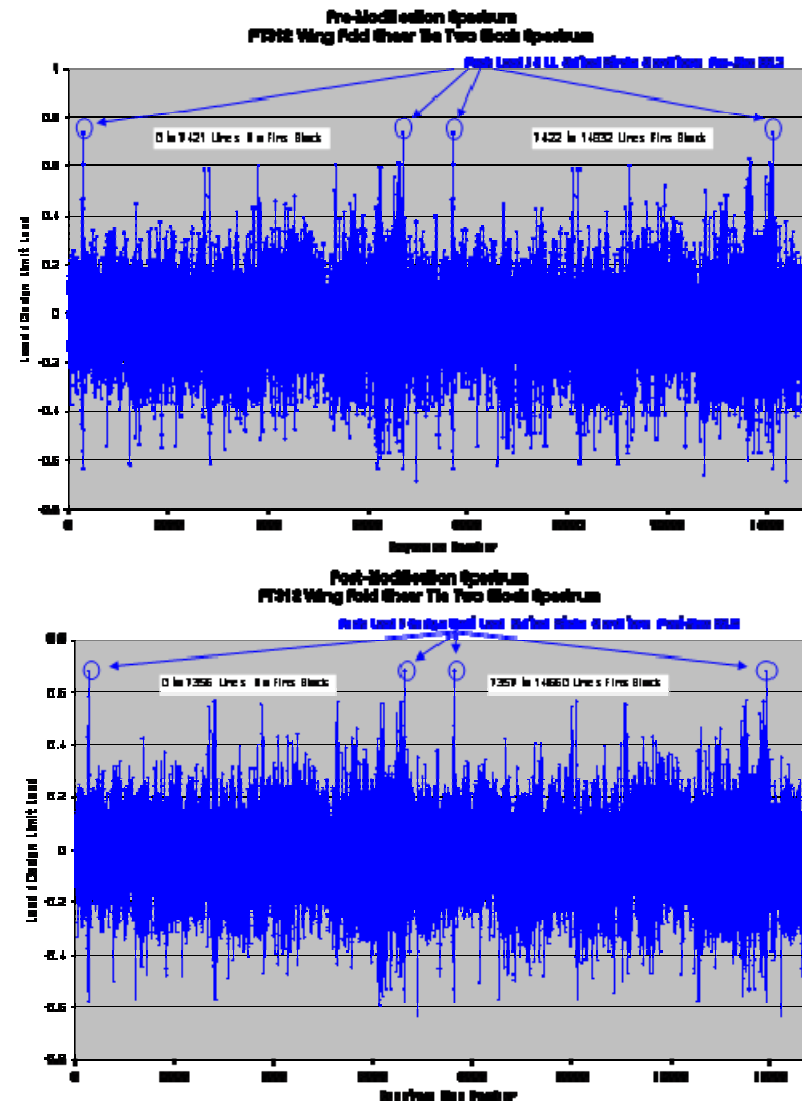
Spectrum

- Alternate fins off/fins on blocks, 7421 and 7411 lines respectively.
- After repair the spectrum adjusted to meet the intended blend stress.
- Required peak load post mod to be reduced by ~ 8%.

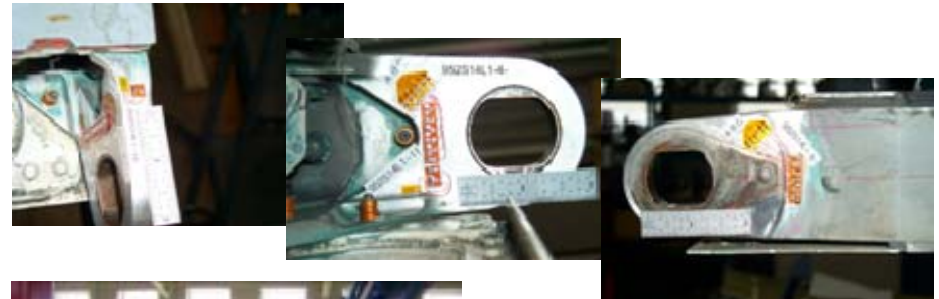
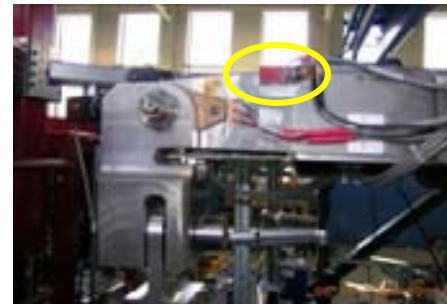
Ultrasonic Sensor

- Eight strain gauges installed.
- Ultrasonic sensor located on the shear-tie, opposite the critical radius, to monitor flaw size.
- Digital image correlation.

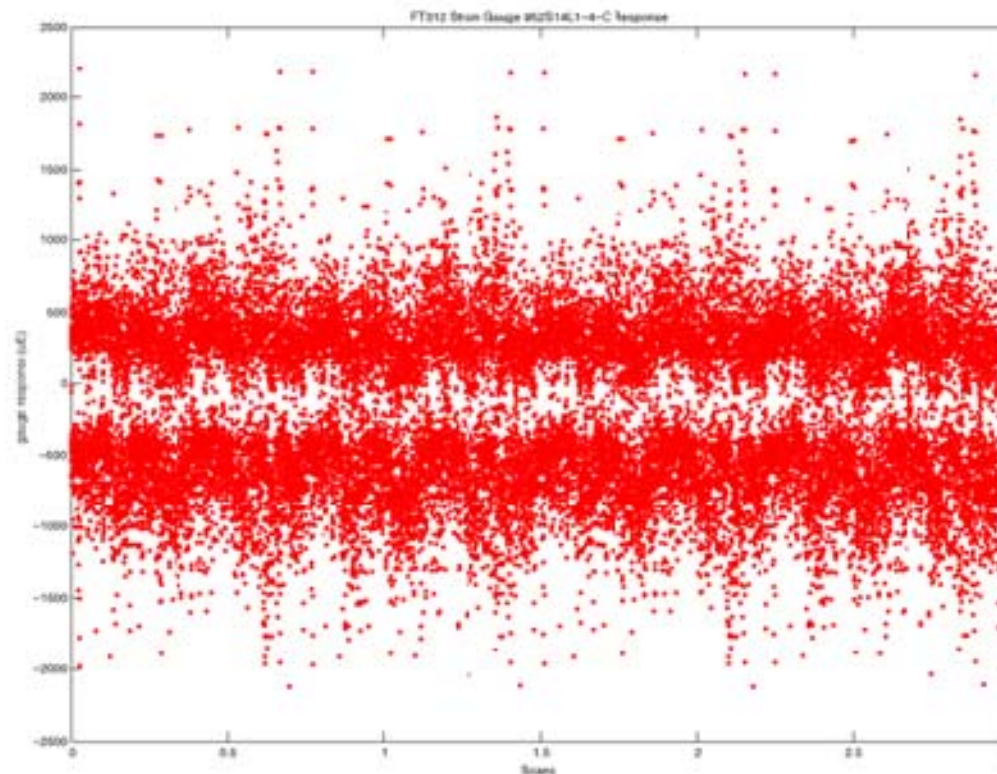
Strain Sequences...

- Full Sequences - load & strain were recorded - blocks 1, 2, 3, 4.
- After the spectrum changed blocks 15 and 16.

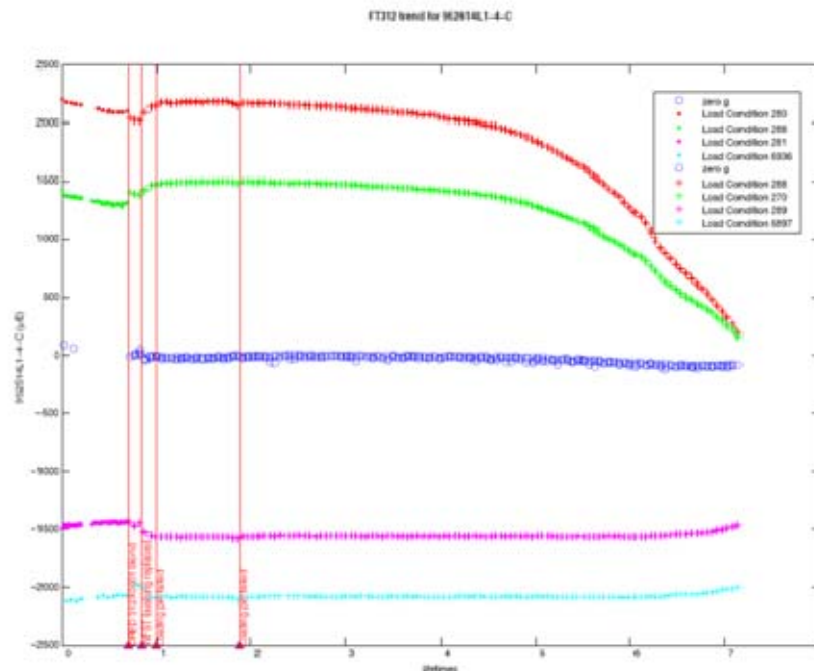
Trend Monitoring...

- All blocks - a limited number of end levels were recorded to enable trend monitoring.
- 73%, 47%, -47% and -69% of design limit load (DLL) during the pre-modification spectrum.
- 68%, 47%, -47% and -63% DLL during the post-modification blocks

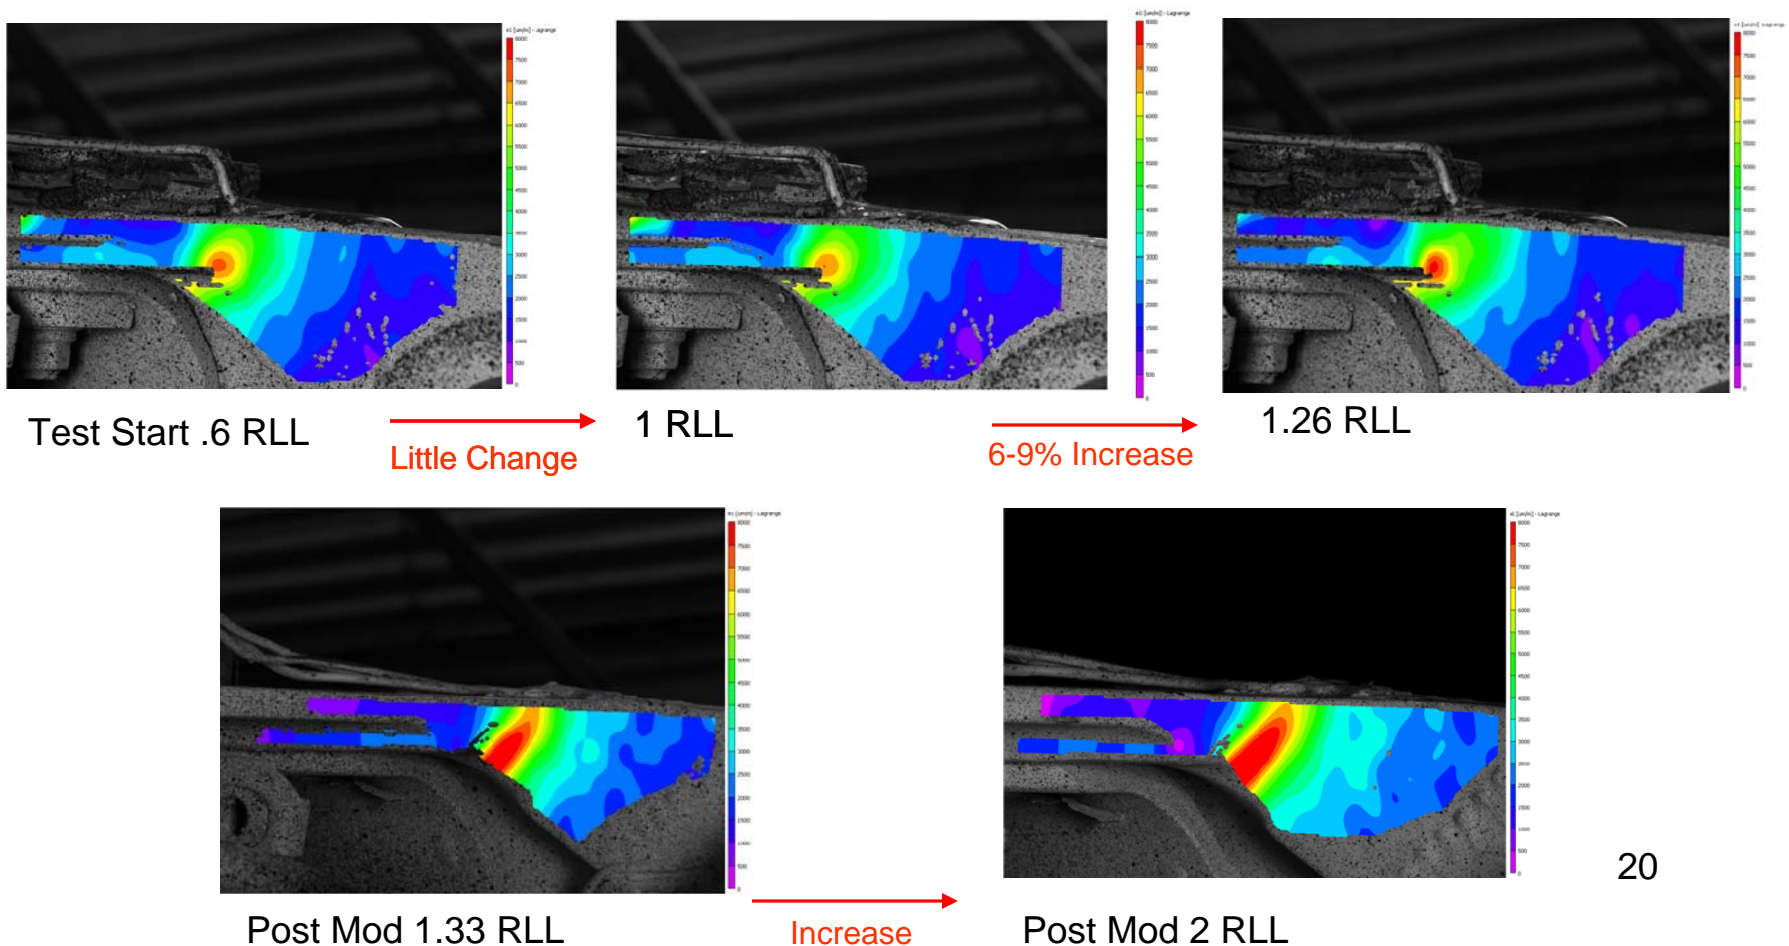
Digital Image Monitoring...

- All blocks – each peak down load was recorded to enable trend monitoring of surface strains.

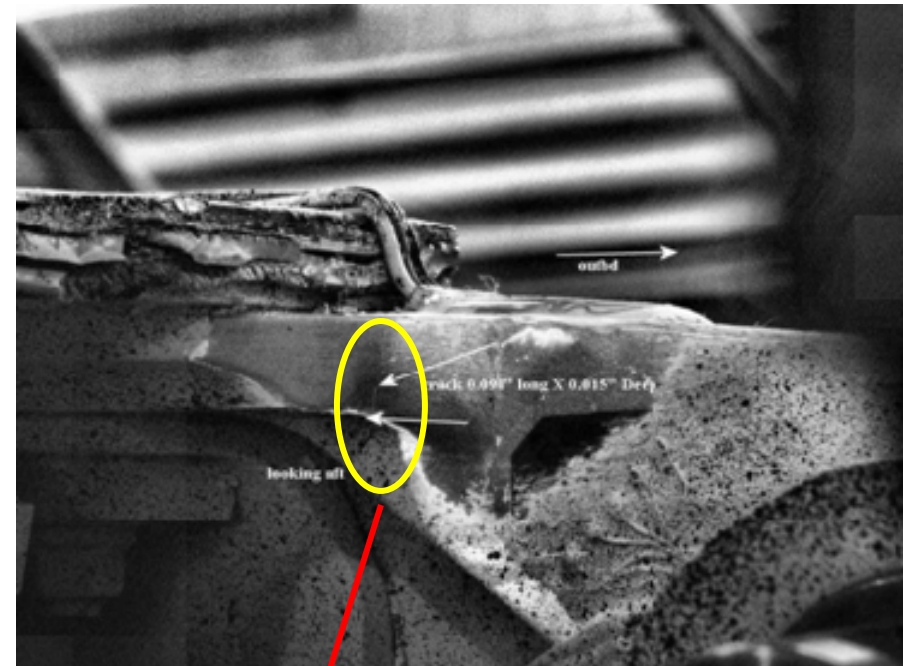
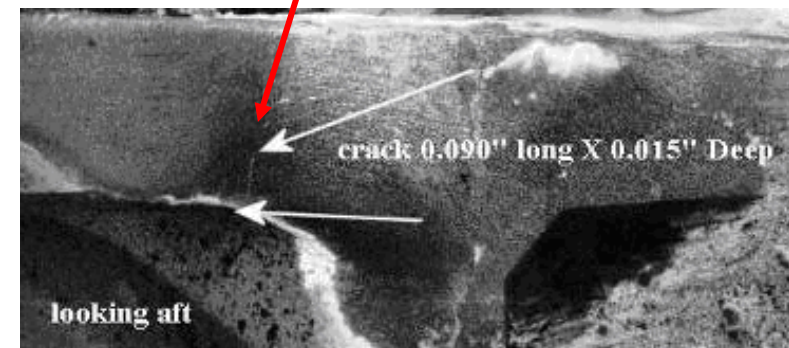
Inspection...

- No planned inspections.
- Automated ultrasonic inspections continuously.
- Surface strain measurements.
- Ultrasonics set to 0.13-0.25 mm first triggered at 1 RLL to stop testing.
- 49 Ultrasonic stops from 1 - 1.3 RLL.
- Test stopped LPI inspection 1.32 RLL.

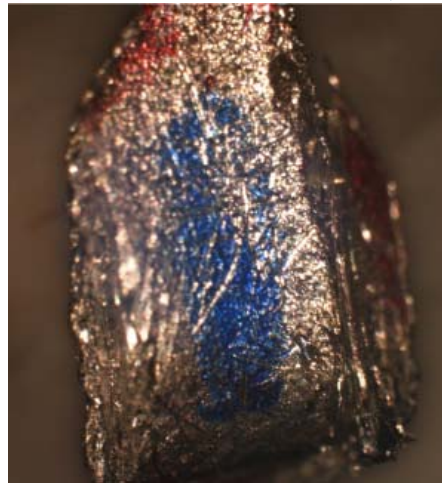
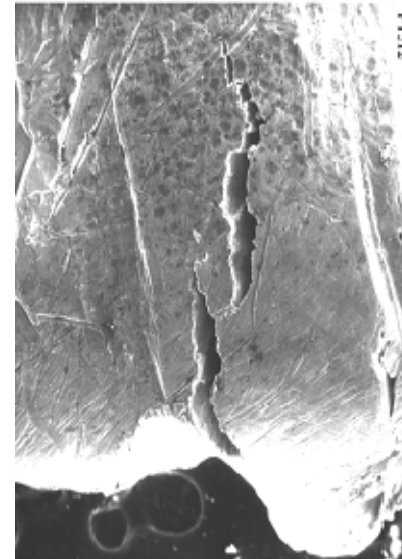
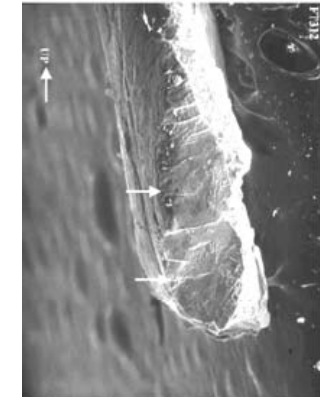
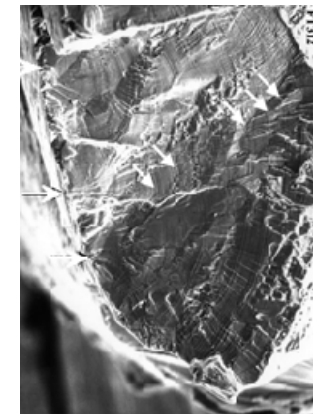
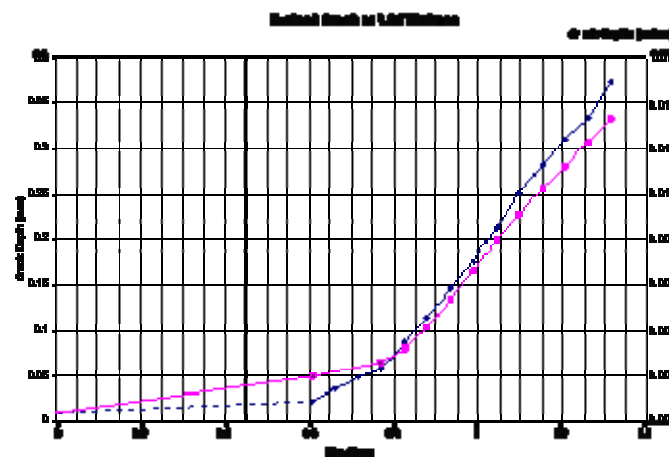
Crack Excision... Quantitative Fractography

- Crack excised.
- Quantitative Fractography.
- Crack Growth.

QF carried out by QETE – Dr. Roth

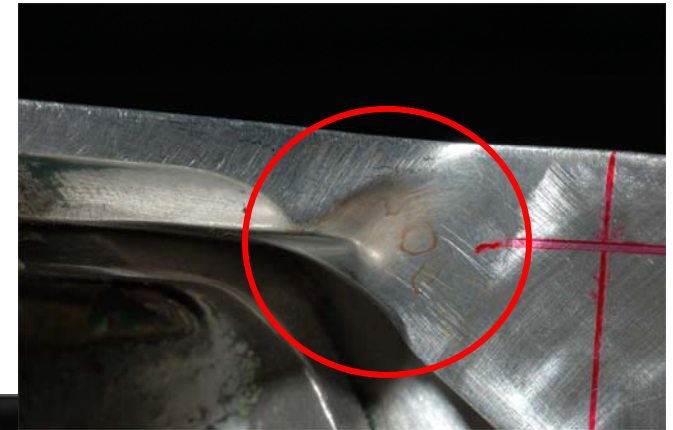
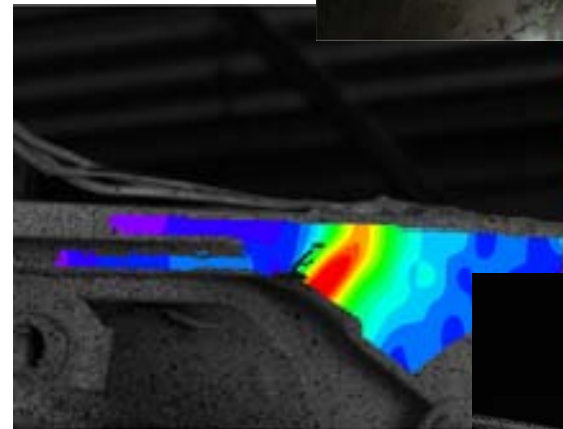
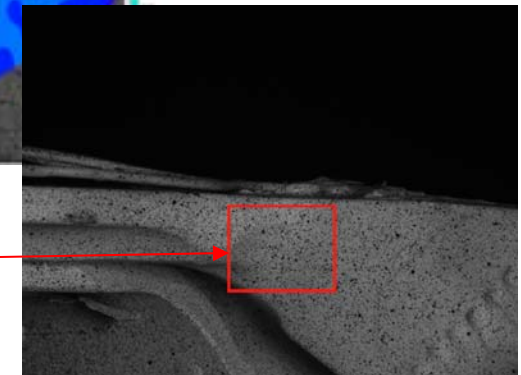
Repair... Blend

- At 1.32 RLL the a hand blend and polish of the cracked area.
- Area was repainted for surface strain measurements.
- High strains measured.
- Image correlation also used to extract blended geometry for FEM.
- Resulted in spectrum modification of peak loads.

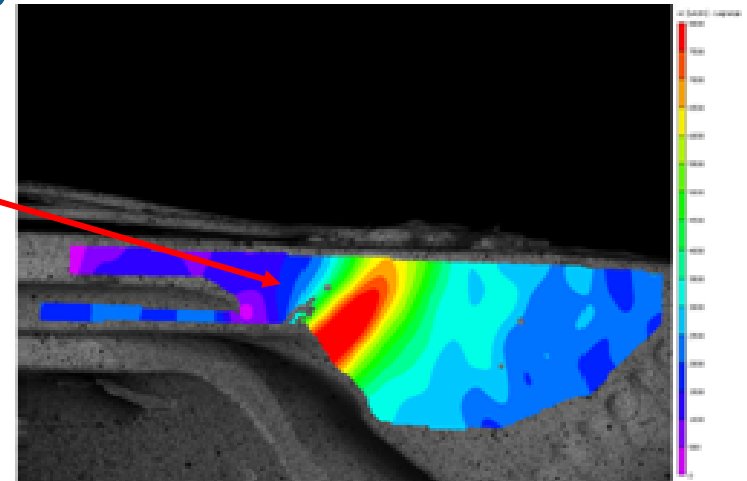
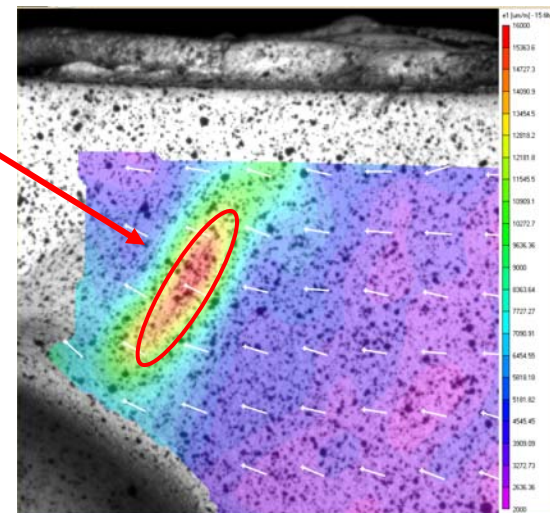
Continued... Testing

- By 2.0 RLL strains were increased in the critical area.
- Visible cracking found at 2.3 RLL.

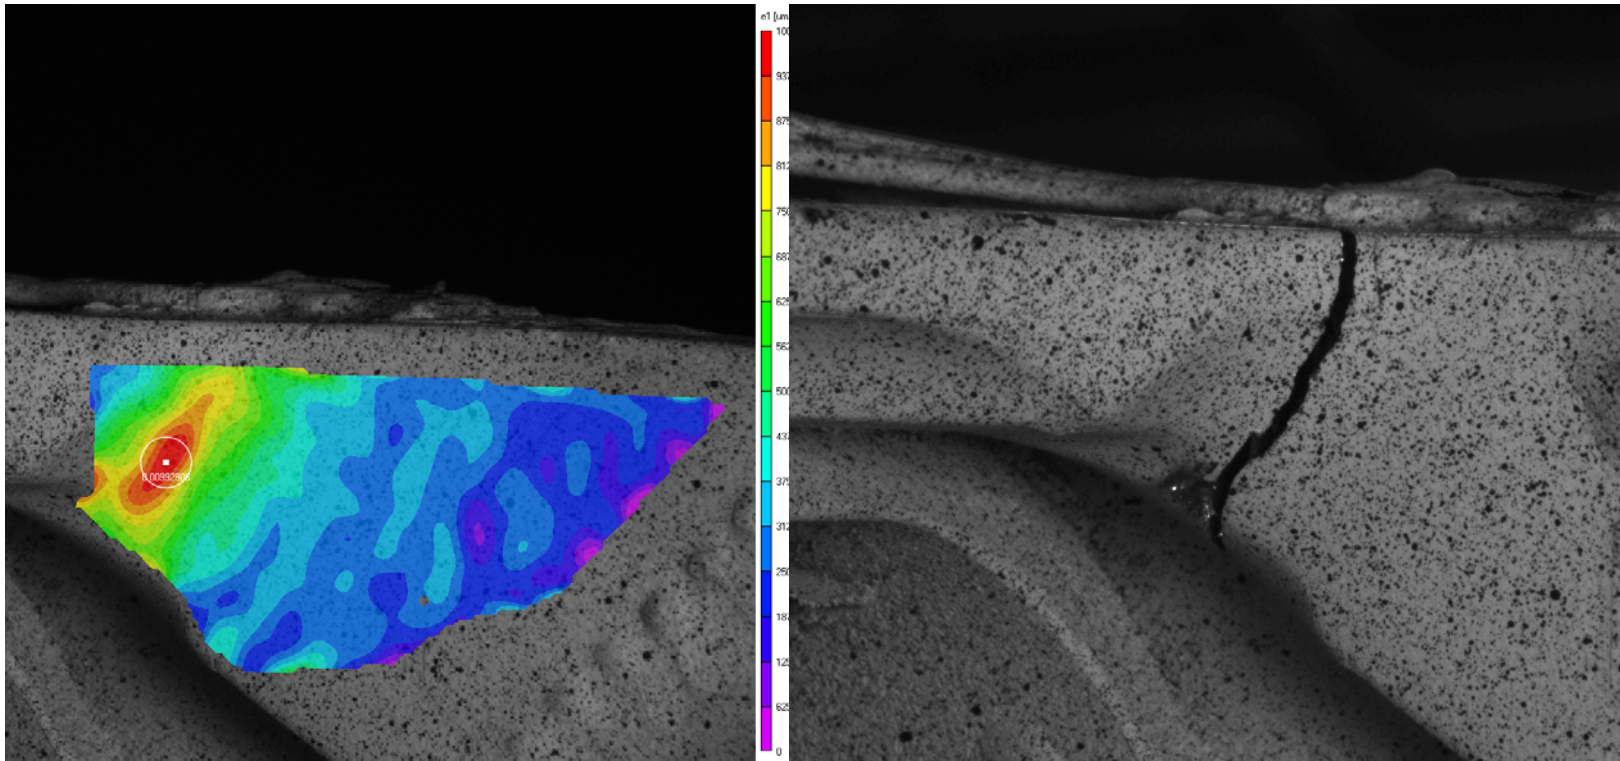
First Principle strains

- Triggered digital image correlation - monitored growth 24/7.
- Fatigue testing required minimum 5 RLLs post-modification.

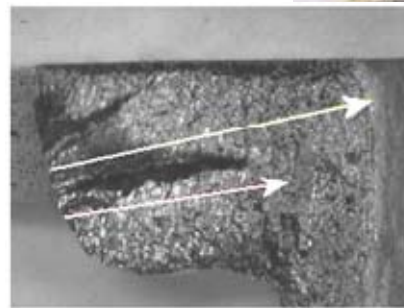
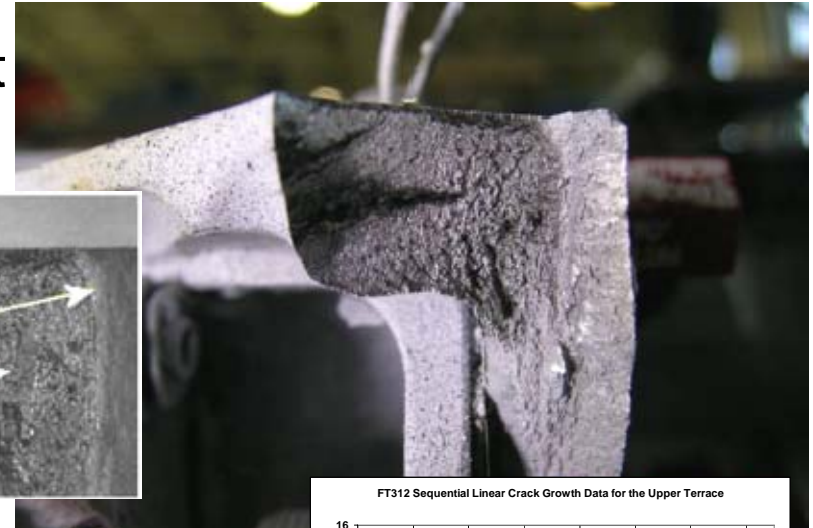
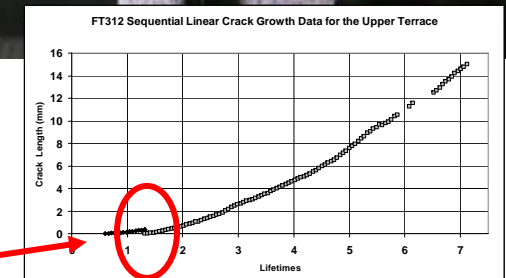
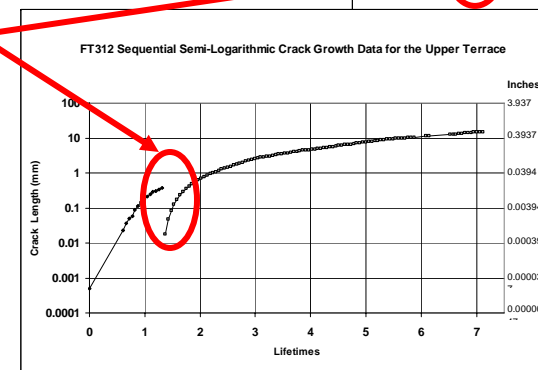
Residual Strength... Testing

- At 7.75 RLLs a residual strength test to failure was carried out.
- Failure surface used for quantitative fractography.
- QF confirm long stable cracking.
- Mod delayed the cracking of fitting by only 43% of one RLL.

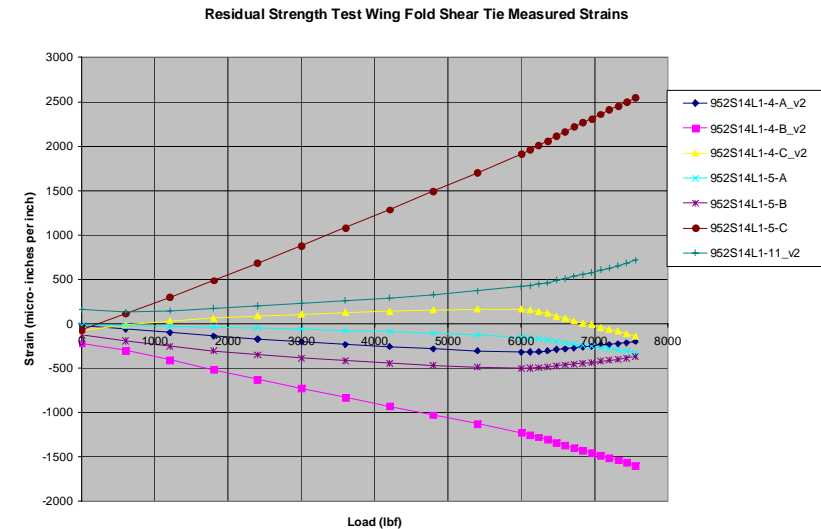
Residual Strength Test

- The residual strength test applied loads in 10 % increments to the spectrum peak.
- Loads were then applied in 2% increments to failure.
- Failure occurred at 87.5% DLL and 128% of the peak spectrum.
- Strains measured by gauges did not exceed 3000 microstrain.

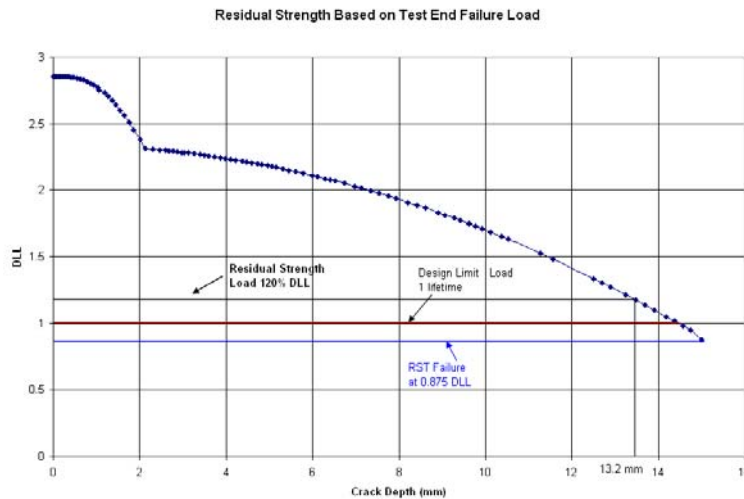
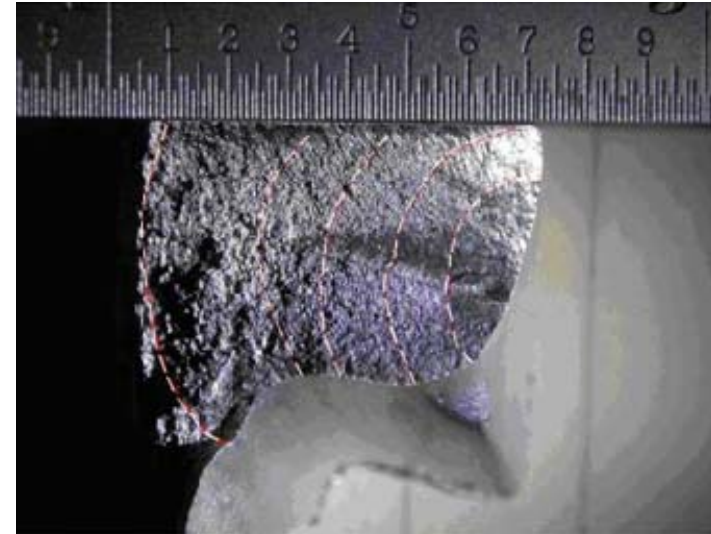
Residual Strength Test

Tested to 87.5 %DLL....
120 % DLL req'd ...

- Post RST found semi-circular fatigue cracking.
- Failure stress was estimated and RST curve was generated.

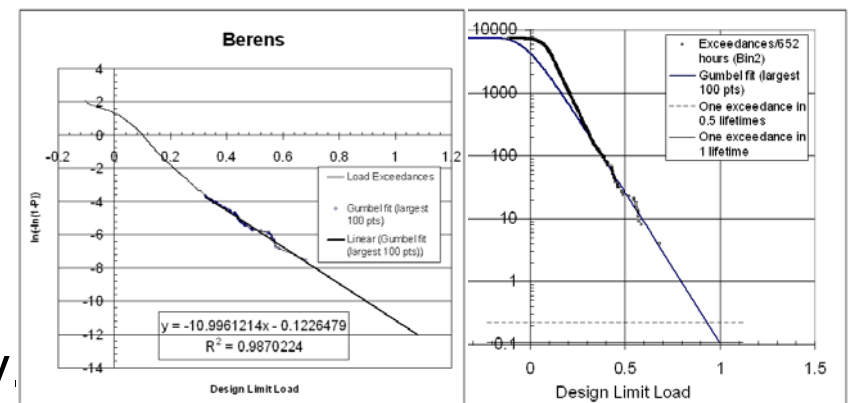
- DLL defined, Gumble extrapolation of test spectra- Berens Methodology

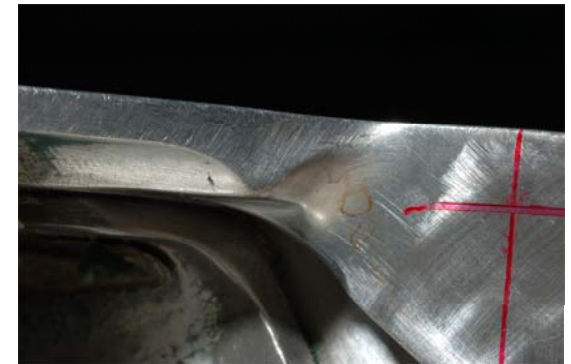
Conclusions

- Testing generated in-service typical cracking in 1.32 RLL.
- Crack was excised & QF generated crack growth data.
- Lug was hand blended by R&O.
- Post mod cracking to the same 0.5 mm occurred in ~ 0.4 RLL.
- Testing continued for 6.4 RLL with stable crack growth.
- RST carried out.
- Critical crack size - 13 mm. at 120% DLL.
- If a safety by inspection damage tolerance methodology is applied vs durability safe life approach, the WF Shear Tie inspection recommended @ $\frac{1}{2}$ RLL post-modification, with subsequent inspections @ $\frac{1}{2}$ RLL.
